MAY 7, 1919

AN INVESTIGATION OF THE PROTECTIVE VALUES
OF STRUCTURAL STEEL PAINTS

By
J. S. COYE

BULLETIN 54
GOOD ROADS SECTION
ENGINEERING EXPERIMENT STATION

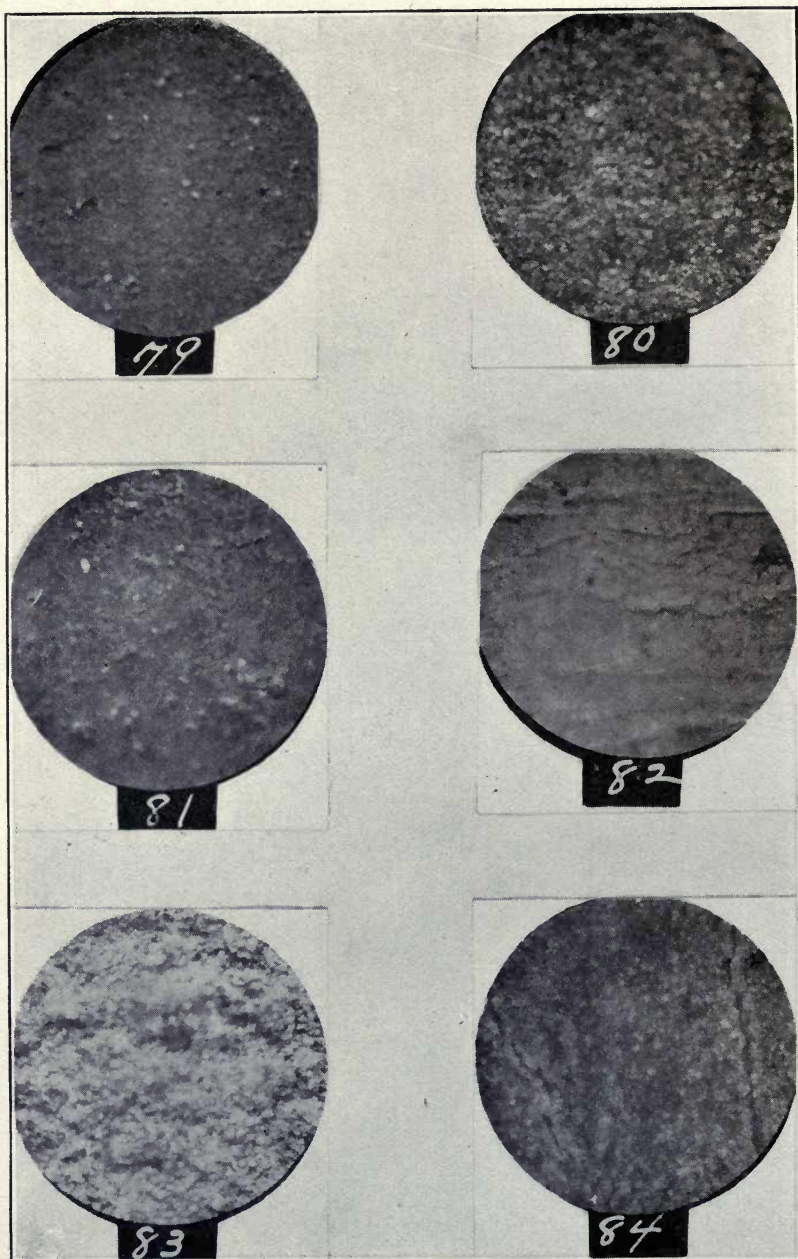
Microphotographs of Panels 79 to 84
Exposure: 79-80 about twenty-two months; 81-84 about twenty-one months

Carbon paints are very serviceable and when properly and scientifically prepared produce a very elastic and impervious film. However, the results of these tests show that this class of paint should not be used as the first coat on metal, as rusting, altho delayed for several years, will begin beneath the paint film unless very careful attention is paid to keeping the surface repainted. As a field coat carbon paints are very valuable. See panels 1, 14, 17, 30, 36, 81, 108 and 134.

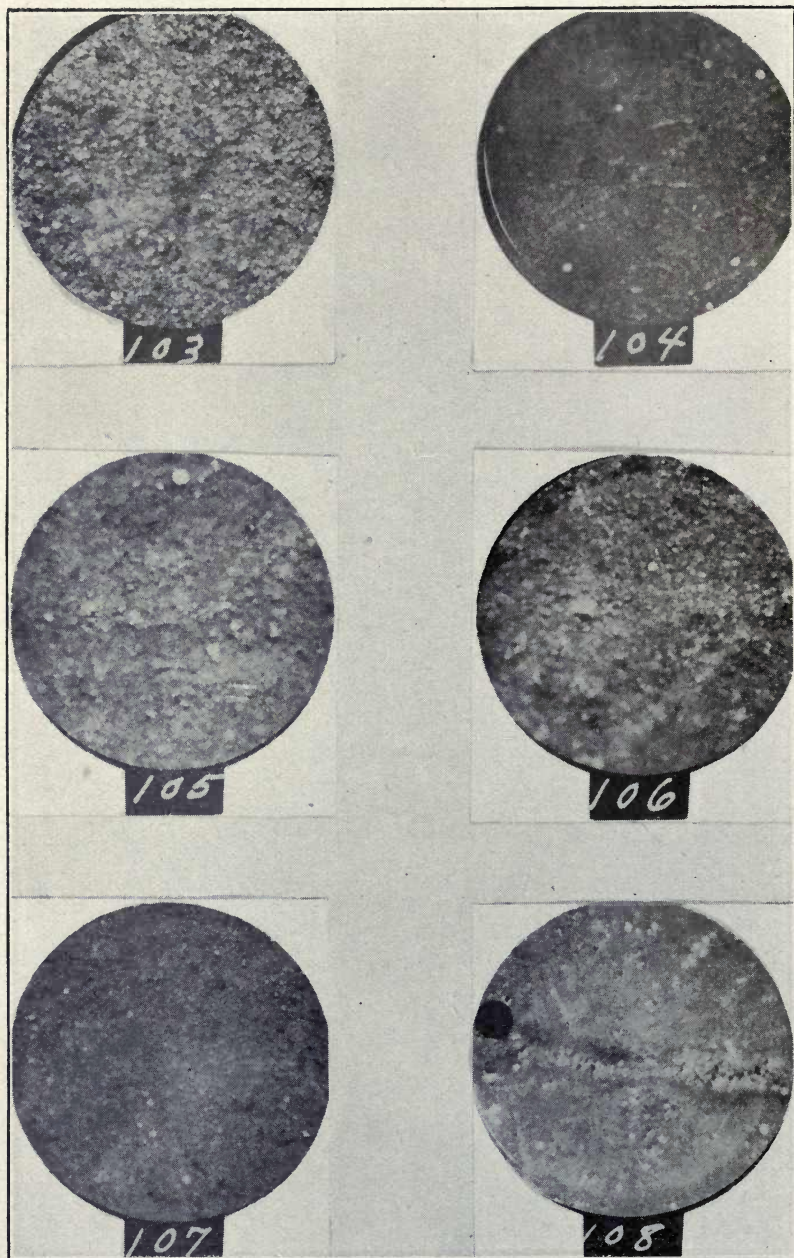
Microphotographs of Panels 103 to 108
Exposure: 103 and 106 about twenty-two months; 104, 105 107, 108 about twenty-one months

Asphaltic base paints are similar to coal tar paints but do furnish considerable protection if properly made. Panels No. 1, 104 and 49 were coated with a paint containing an asphaltic base and are still giving good protection. However, panels 23, 124 and 125 coated with asphaltic base paints, have failed completely and must be burned, scraped and repainted. Gilsonite paint produces a brittle film which allows water to pass through to the metal; then corrosion proceeds rapidly.
